RE: Site Inspection, Molycorp, Small Fry Project, M/037/022, San Juan County, Utah

Molycorp, Small Fry Mine

M/037/022

Photographs  
M/037/022  
Small Fry Mine

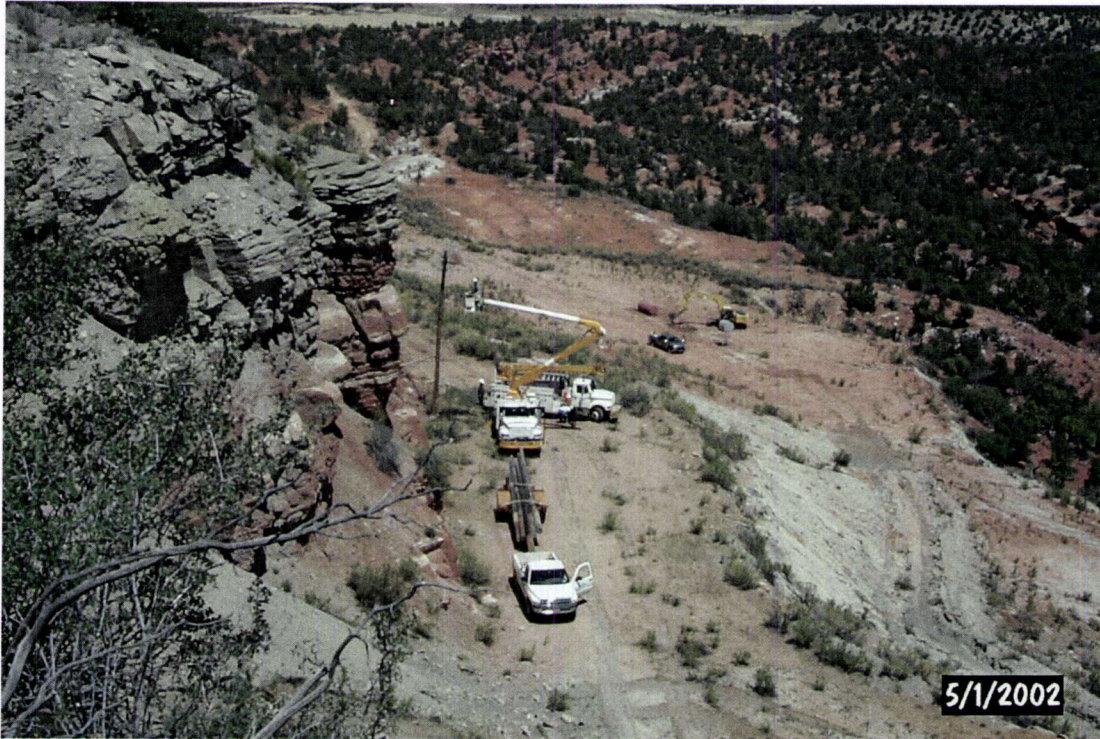
This is an underground mine with two portals at the base of a cliff. The road enters from the north, goes by one of the portals, then forms a loop up toward the other portal and down to a pad. Photo 1 shows the lower pad in the background and the area near the upper portal by the power company workers. All that we could see of the lower portal was some timbers.

There were two fuel tanks on the lower pad, one on skids and the other on a stand. There was a trackhoe on the lower pad and a small dozer on top of the cliff above the upper portal (the place from which Photo 1 was taken). As can be seen from Photo 1, the power poles were being removed while we were there. There was little or no other debris or equipment.

Photo 1. Utah Power and Light personnel removing power poles with trackhoe and fuel tanks in the background.

We discussed some general reclamation concepts with the contractor. It should be possible to push a certain amount of fill into the portals using the trackhoe. As far as possible, the vegetation on the slopes should be retained as much as possible while grading the site.

Mr. Jensen and I emphasized the importance of leaving the site extremely rough. Gouge marks that are about one to two feet deep hold moisture, reduce erosion and offsite sedimentation, and increase vegetation establishment and growth.

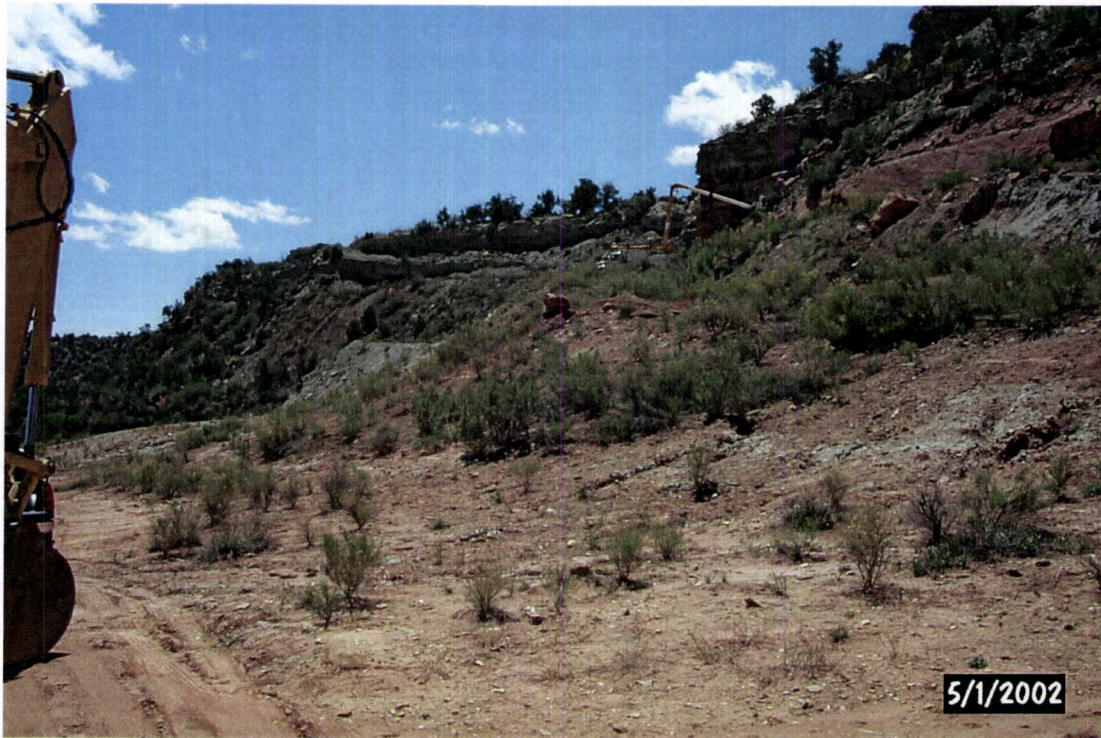
Most of the slopes had well established stands of rabbitbrush, but the waste piles were poorly vegetated (Photo 2). The pads had little or no vegetation.

Photo 2. Slopes between the upper and lower roads.
